LEVEL 2

Your survey report

Test Avenue
Nowhere Ville
M1 5UT

18th May 2023

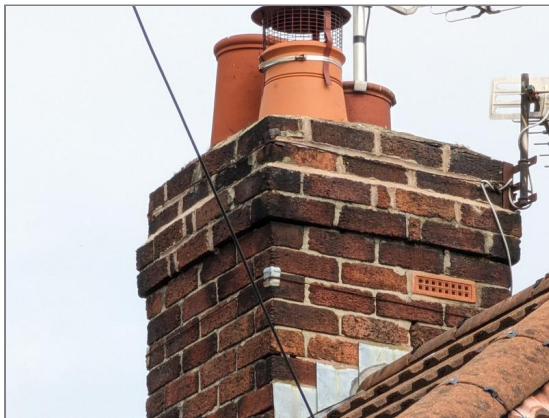
The brick stack and the lead flashing around the base are in fair condition with no major repairs required and should be maintained in the normal way which should include some non urgent routine pointing where mortar has started to erode between some of the bricks. You should also consider replacing a number of bricks which are frost damaged / weathered but again this is not an urgent matter.

Photo - 1 Front and side face of stack

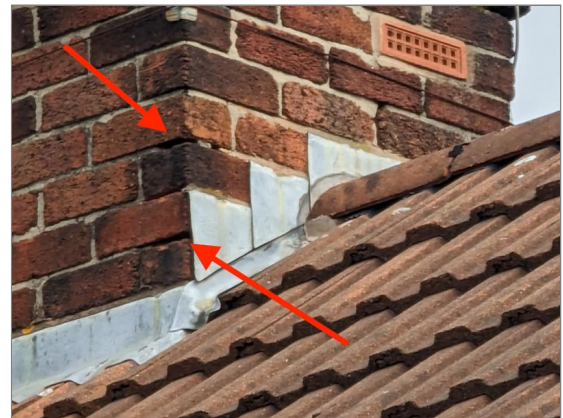
Photo - 2 Localised repointing is now due in some areas

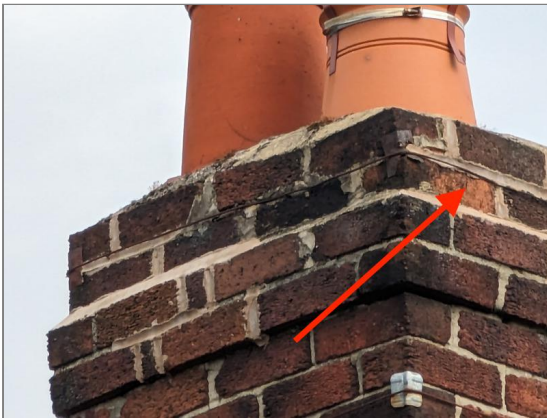
Photo - 3 Weathered brick faces in some places

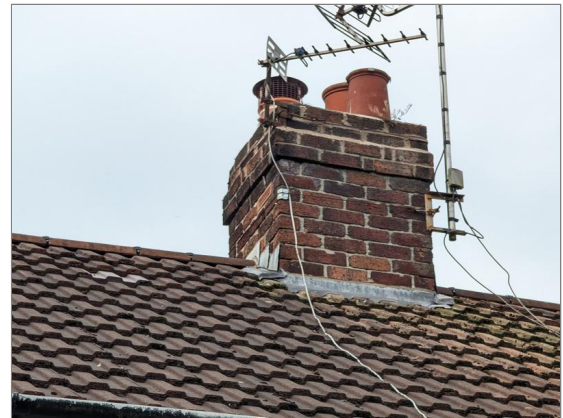
The owner of the neighbouring property may have a number of legal rights over this shared chimney. You should check with your legal adviser before any work is done (see section H3).

Photo - 4 Rear face of shared stack

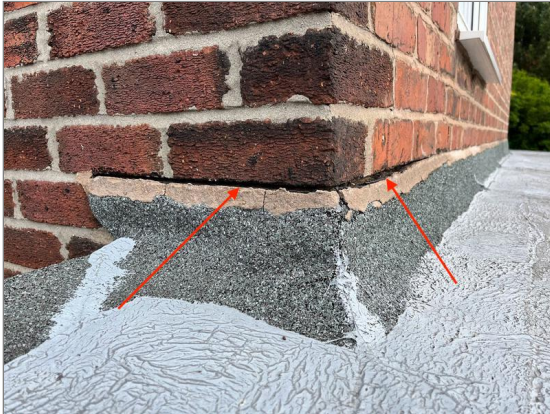
The pointing at the junction of felt up stand of the roof and the walls of the house is weathered and should be repaired / pointed to ensure it remains watertight.

Condition rating 2. These works should be carried out soon after purchase.

Photo - 5 Pointing required at junction of flat roof upstand and main walls.

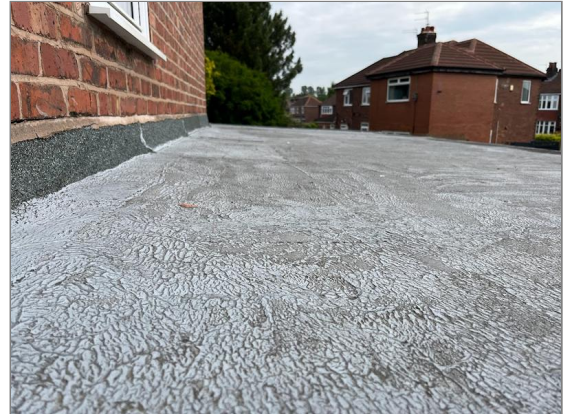
The suspended timber roof of the extension area is flat and covered with mineral felt with a protective waterproof coating. Flat roof coverings do not last as long as those on sloping roofs and they can quickly fail and leak. A 10 to 15-year life expectancy is typical. It will require regular maintenance before its eventual replacement. At the current time, the roof finish is in a reasonable condition with no evidence of internal water penetration on the ceilings below. It is typically weathered which could in time create internal damp problems.

In common with most flat roofs of this age ventilation and insulation to the void between the ceiling and the external covering is probably inadequate and this can lead to issues with damp and cold spots. Upgrading would effectively require replacing the whole roof, so at this stage, I would advise that you wait until the external covering starts to fail.

Photo - 6 Flat roof covering - weathered.

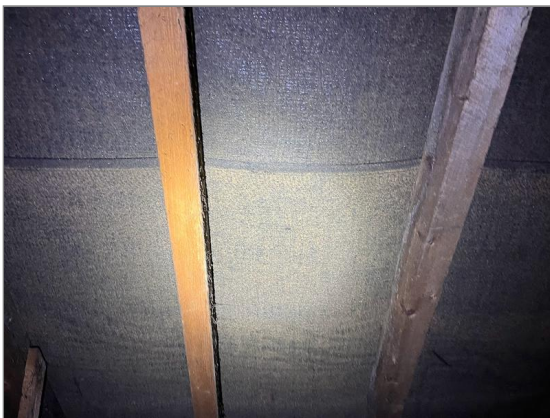
The roof coverings and ridge / hip tiles were found to be in an acceptable condition with no repairs currently required and the secondary waterproof layer (roofing felt) on the underside of the roof is where visible in satisfactory condition.

Photo - 7 Secondary waterproof layer (roofing felt).

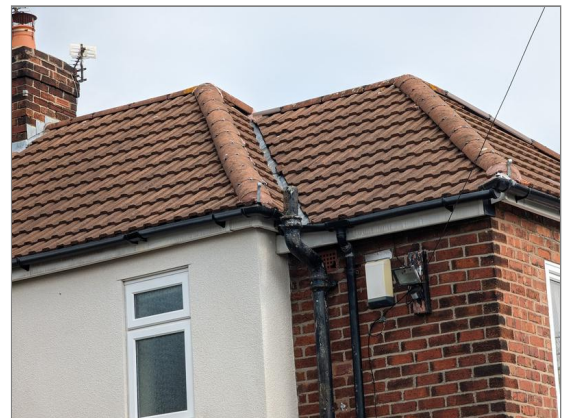
The original roof tiles have been replaced. These concrete tiles may be heavier than the original roof tiles and additional strengthening may have been required. I advise that your solicitor makes checks to see if building regulation approval was sought and complied with when these works were carried out (see section H1).

Photo - 8 Replacement roof coverings satisfactory

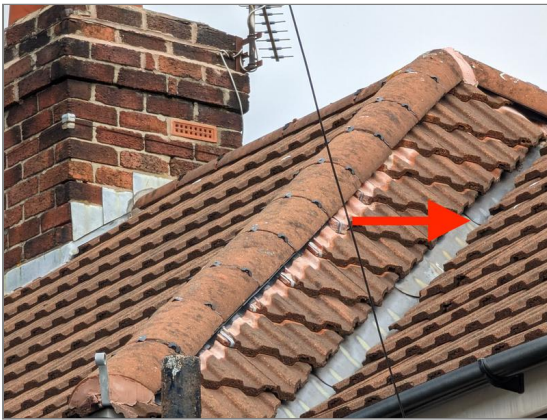
The sloping valley gutter at the junctions of the main roof slopes and the hipped sections are lined with lead. These should be regularly cleaned of any debris and checked as these types of lined gutters are vulnerable to leaks. The timbers on the underside of the valley gutter were dry when tested.

Photo - 9 Valley gutters ok

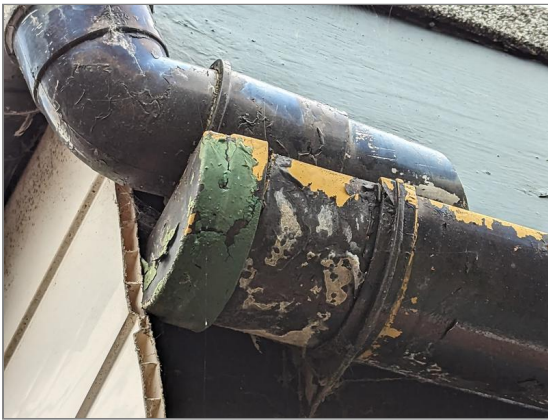
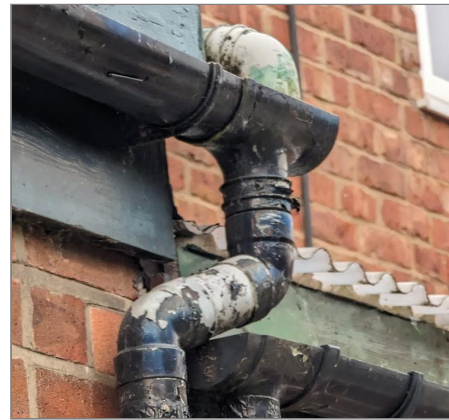
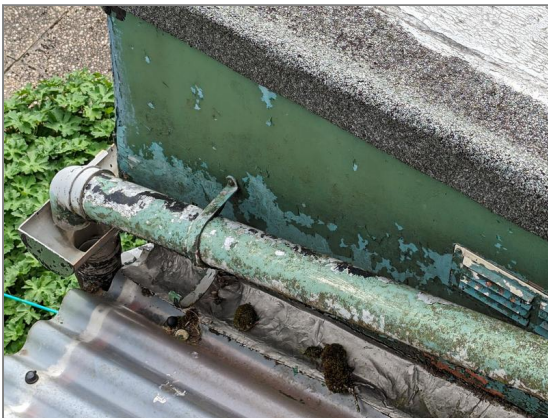
Some of the rainwater downpipes and gutters are dated and show typical signs of age and will need higher levels of maintenance in the future. Whilst replacement is not essential at this time, it may be more economical to replace them with new low maintenance plastic materials.

Photo - 10 Dated rainwater goods

Photo - 11 Dated rainwater goods

Photo - 12 Dated rainwater goods

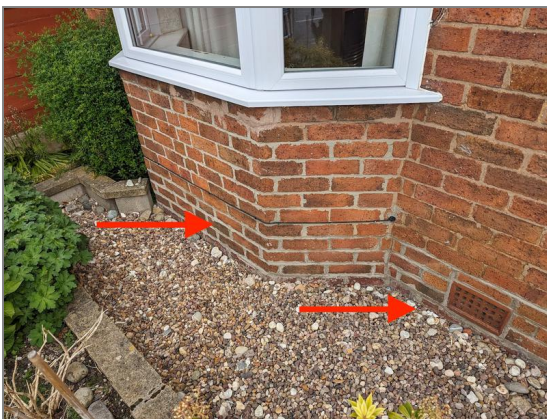
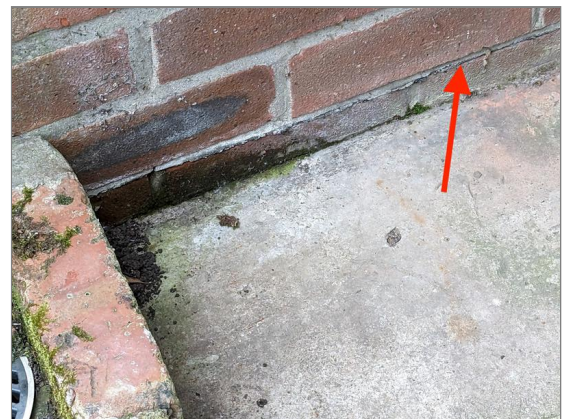
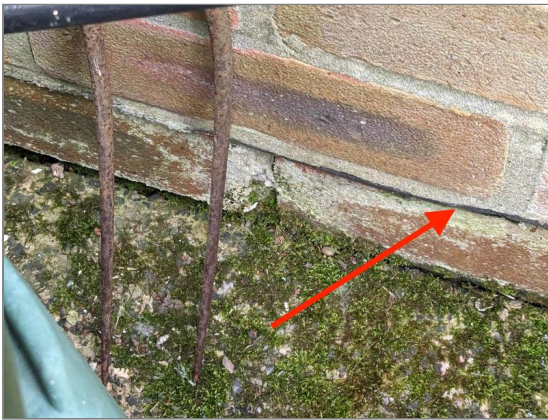
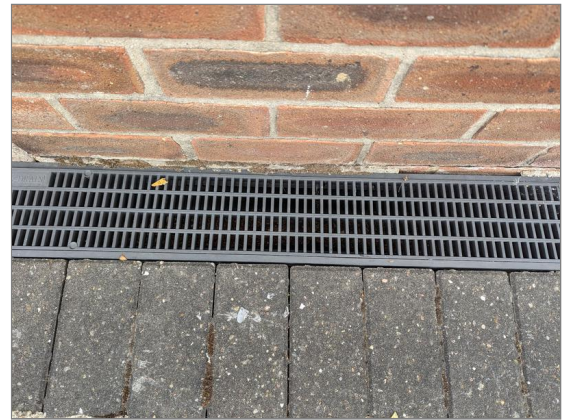
The original bitumen felt DPC (damp proof course) added when the property was constructed is in danger of being bridged by high external ground levels at the front and rear of the property. Unless relatively straightforward remedial works are carried out it could lead to problems with penetrating damp inside the property (see section E3 & E4). A DPC should be positioned so that there is a minimum of 6 inches / 150 mm above the ground. If this gap is reduced it can provide any damp or moisture a direct route over the DPC and into the external wall. An effective way to deal with this issue is to create a drainage soak away channel around the base of the affected walls. These are usually filled with gravel or finished with a grid. A suitable grid has been fitted at the base of front wall of the garage conversion and this should be extended around the base of all the walls.

Photo - 13 Create soak-away around all of the external walls (concrete is below the gravel)

Photo - 14 High ground levels - bridging DPC - create soakaway

Photo - 15 High ground levels - bridging DPC - create soakaway

Photo - 16 Extend the soakaway grid around all the walls

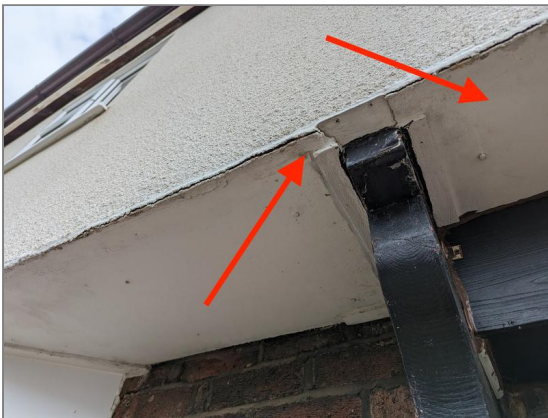
A small section of cladding material on the underside of the front wall above the front entrance area could contain asbestos based materials. Asbestos containing materials are a potential hazard and should not be drilled or disturbed and only be removed or repaired by a specialist contractor (see section I3).

Photo - 17 Possible asbestos content above entrance area

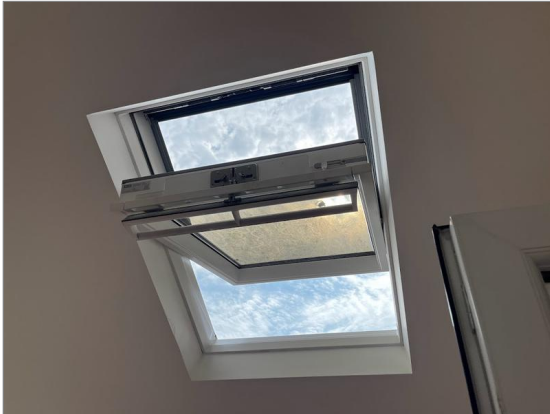
The Velux style rooflights are in satisfactory condition but would benefit from being cleaned. The manufacturer recommends that the rooflight handles, hinges and external waterproofing are and serviced checked annually.

Photo - 18 Velux rooflights - satisfactory.

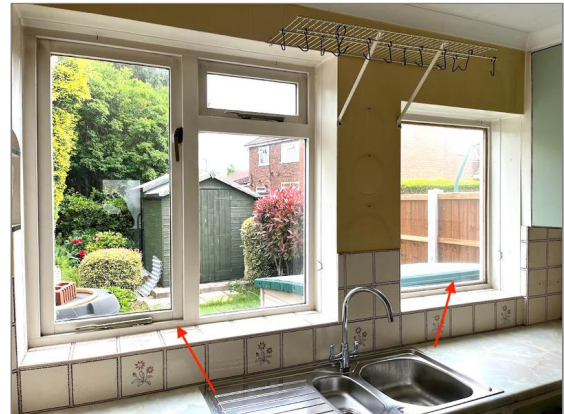
The older uPVC windows in the stairwell and smaller reception room and timber framed windows in the kitchen are in fair condition with no defects noted. These windows will not be as thermally efficient as the rest of the installation and you should consider their replacement.

Photo - 19 Dated timber framed windows in kitchen.

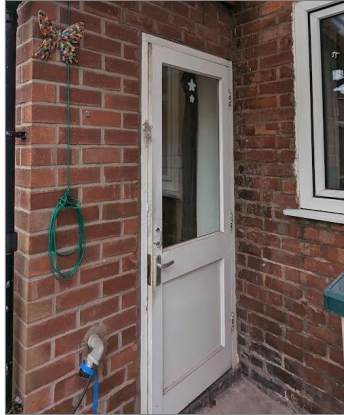
The timber rear door is part of an older installation and whilst in fair condition, it does not provide an adequate level of security. You should consider it's replacement.

Photo - 20 Timber rear door - dated.

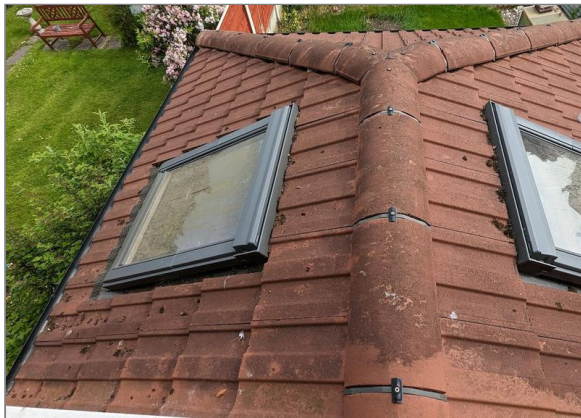
The conservatory features a typical brick base and side wall, uPVC doors and frames and a timber framed concrete tiled roof. It is in fair condition with no evidence of structural problems or water penetration. It is unusual for a conservatory of this design to feature a concrete tile roof which is significantly heavier than the usual plastic or glass roof covering. You should ensure that the replacement roof structure has the benefit of Building Regulations approval to ensure it is not overloading the supporting structure beneath. Should there be no supporting documentation, you should instruct a suitable contractor check the means of support for the roof.

Condition rating 3. These investigations should be carried out immediately

Photo - 21 Ensure adequate support for the concrete tile roof

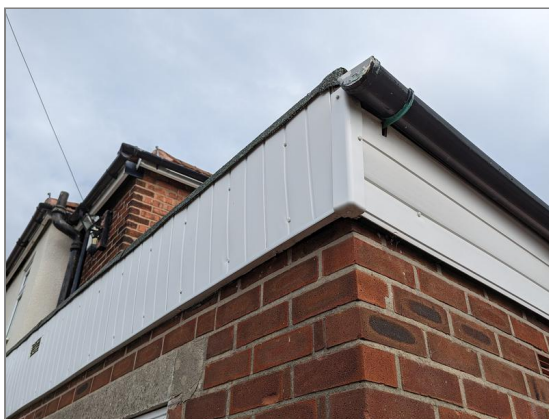
The low maintenance plastic roofline joinery is in satisfactory condition with no significant defects noted. These installations sometimes have the benefit of long term warranties and this should be checked by your solicitor (see section H2). You should note that some installers do not remove the existing timber joinery which may be in poor condition.

Photo - 23 Plastic roof joinery satisfactory

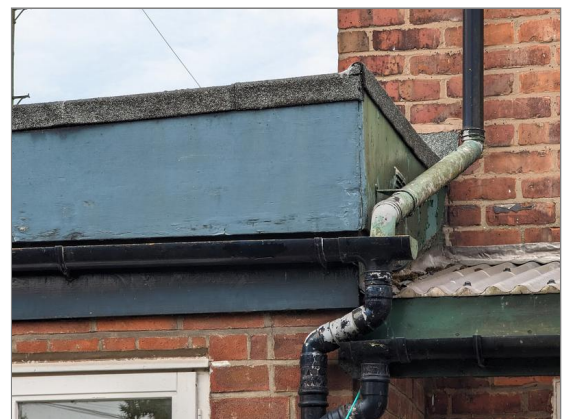
The timber sections are showing signs of age and deterioration with flaking paint and possible wet rot developing in exposed areas which will require some localised repair and routine maintenance. Outside decorations help keep the property in satisfactory condition. Without a protective finish, parts will quickly deteriorate requiring extensive repairs. To prevent this, the external surfaces should be redecorated soon. You may wish to consider completing the installation of low maintenance plastic joinery.

Condition rating 2. These works should be carried out soon.

Photo - 24 Timber sections typically weathered

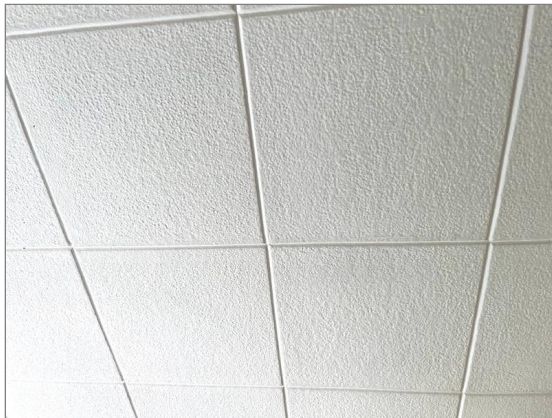
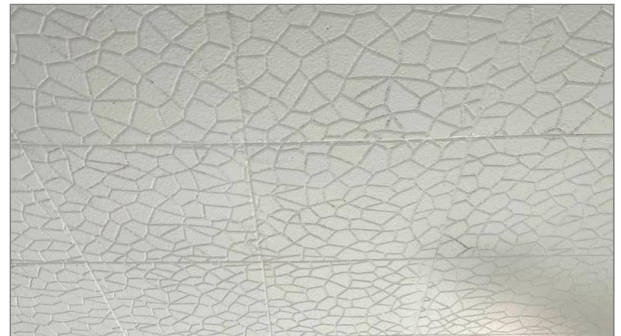
The kitchen and main bedroom ceiling are clad with polystyrene tiles which are a potential hazard. Polystyrene tiles are a safety hazard because they are flammable and give off poisonous fumes in a fire. These should be removed now. This may damage the ceiling underneath requiring more extensive repairs.

Condition rating 3. These works should be carried out immediately.

Photo - 30 Polystyrene tiles.

Photo - 31 Polystyrene tiles.

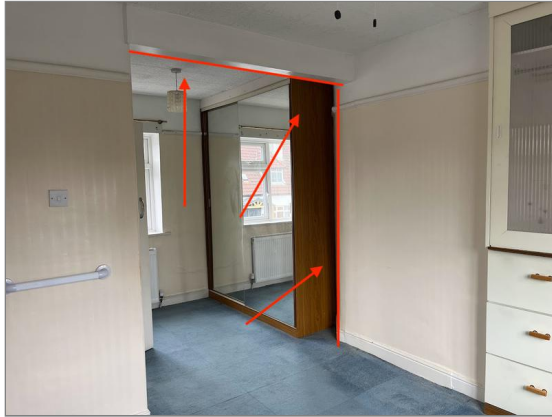
Photo - 32 Internall wall removed.

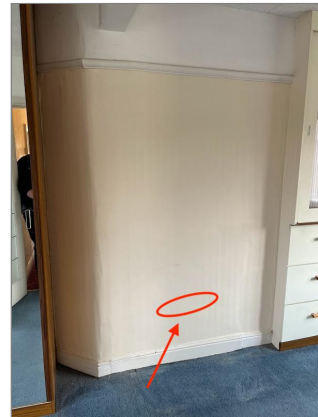
An air vent should be fitted within the chimney breast in order to help prevent moisture and condensation from building up with the brickwork.

Condition rating 2. These works should be carried out soon.

Photo - 34 Chimney breast vent required.

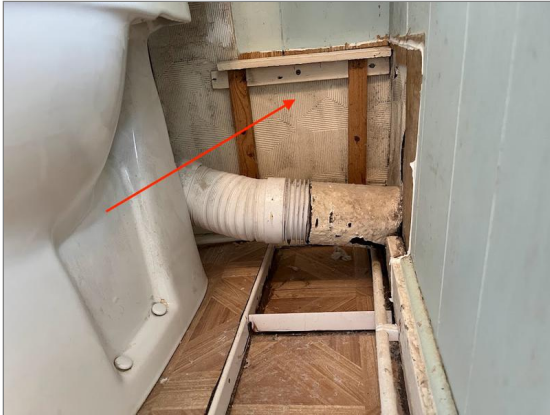
The 'boxing in' around the soil pipe has been removed and will require replacement.

Photo - 36 Replace 'boxing in'

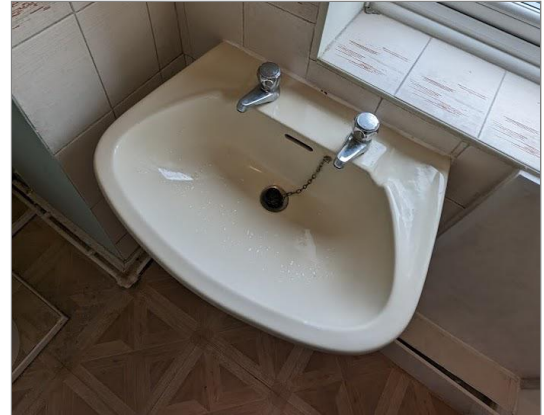
Photo - 37 Basin part of an older installation.

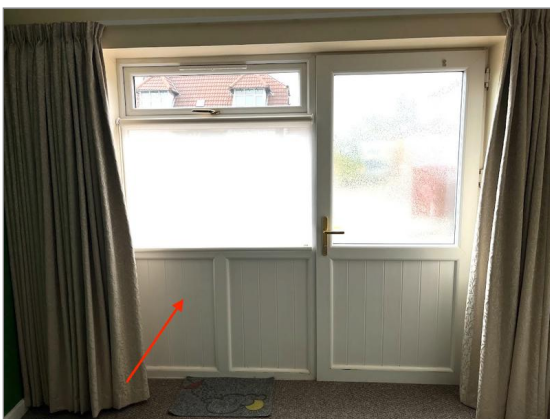
The front elevation wall of the converted garage is constructed of pvc panelling which will be prone to heat loss and condensation.

Condition rating 3. These investigations should be carried out immediately.

Photo - 38 PVC wall prone to condensation and heat loss.

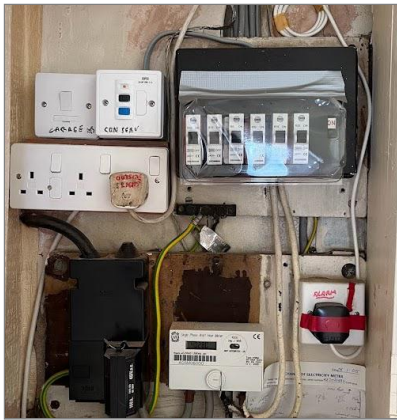
Condition rating 2. These investigations should be carried out soon.

Photo - 39 Dated electrical installation.

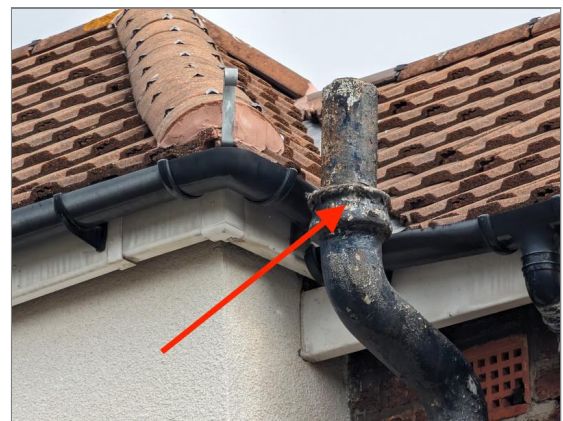
The main soil stack is made of cast iron and parts are typically corroded. An urgent repair is not required but it will need regular maintenance and it may be more economical to replace the whole stack pipe with more modern material. A protective vented cover should be fitted to its top section.

Photo - 48 Dated soil pipe consider replacement

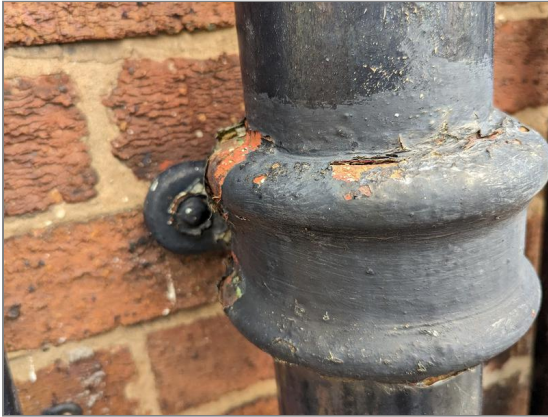
Photo - 49 Typically rusted in places

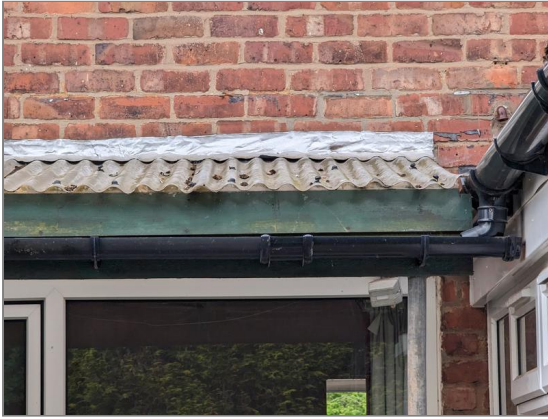
Photo - 50 Dated canopy at rear of house

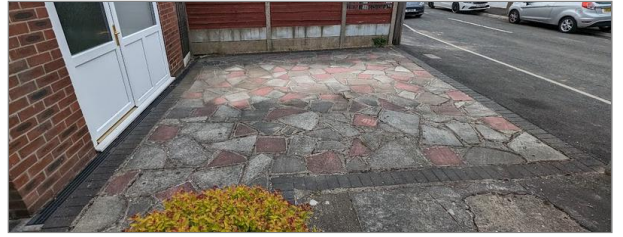
Photo - 51 Dated driveway.
